SSC-294

1. Report No. (18) SSC-294 (19)	2. Government Accession No. AD-A086 049	3. Recipient's Catalog No. (11) May 80
4. Title and Subtitle Ship Structure Committee Project SR-1258 STRUCTURAL DETAILS FAILURE SURVEY		6. Performing Organization (12) 189

Newport News Shipbuilding received a contract on December 6, 1977, from the United States Coast Guard to perform the Ship Structure Committee Project SR-1258. This project titled, "Structural Details Failure Survey, Part II," is a continuation of the Ship Structure Committee Project SR-1232, "Structural Details Failure Survey,"<sup>1</sup> completed in June, 1977, by Newport News Shipbuilding. In Part II, structural detail failure data and percentages of failures for twelve families of details were collected from surveys of the midship/cargo sections of thirty-six ships. The thirty-six ships included three ship types, bulk carriers, containerships, and general cargo ships. This project, under the advisorship of the National Academy of Sciences, Ship Research Committee, is intended to extend and confirm the conclusions of the report titled, "In-Service Performance of Structural Details."<sup>1</sup>

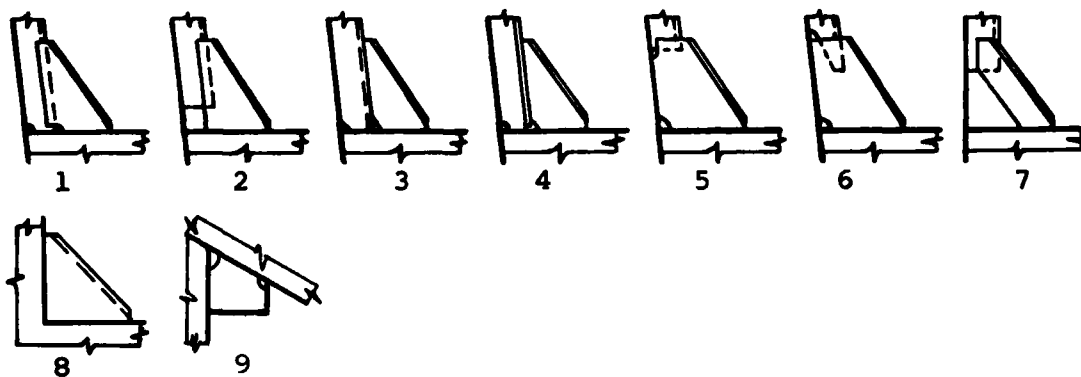
**M.**

The transition brackets of family group "M" were quite common near the turn of the bilge and, thus, were quite susceptible to corrosion. Proper design, such as drain holes to prevent standing water and elimination of inaccessible areas, coupled with a regularly enforced maintenance program, would have prevented failures in this area.
